Close Out Documents

AP-83 – 4625 Milwaukee St.

Asbestos Abatement and Structural Demolition

Structure Survey Assessment Report AP-83

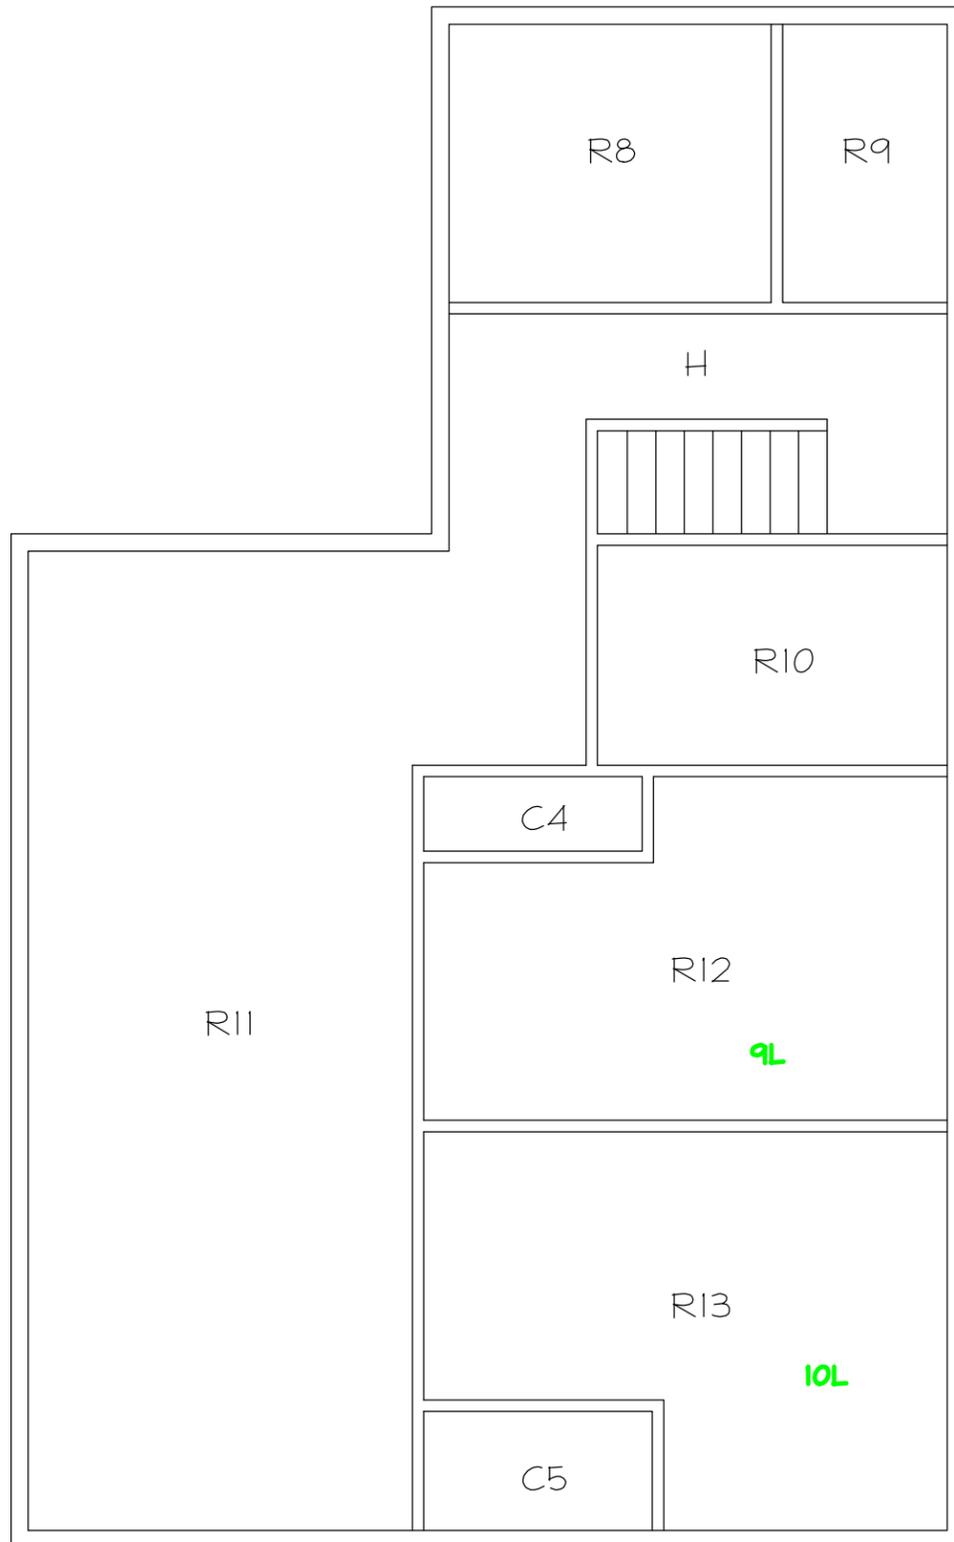
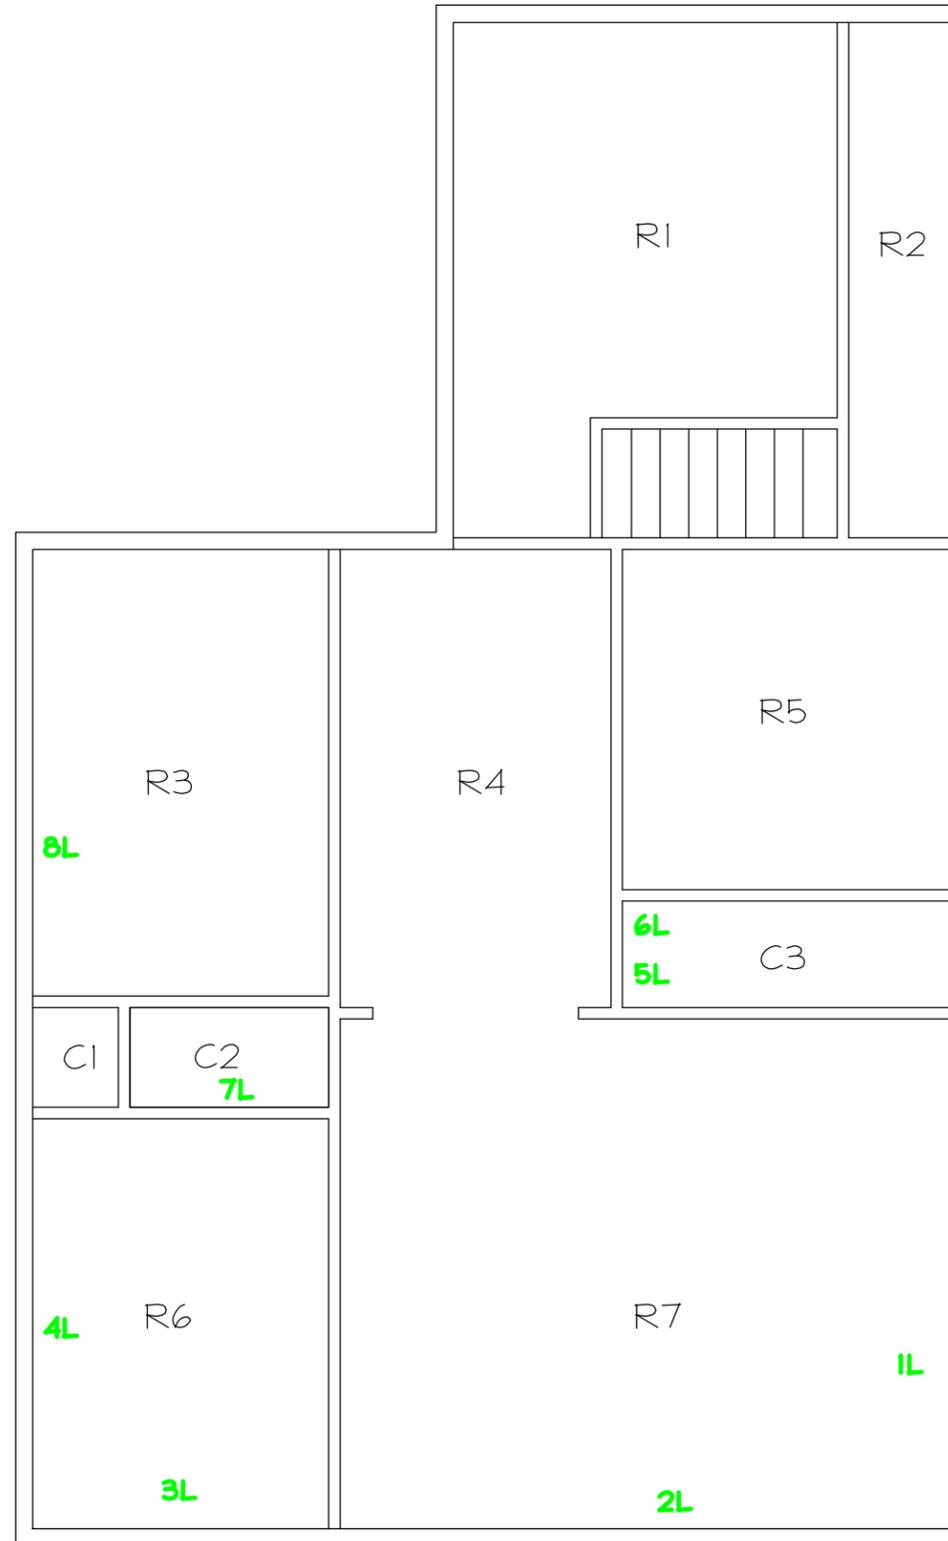
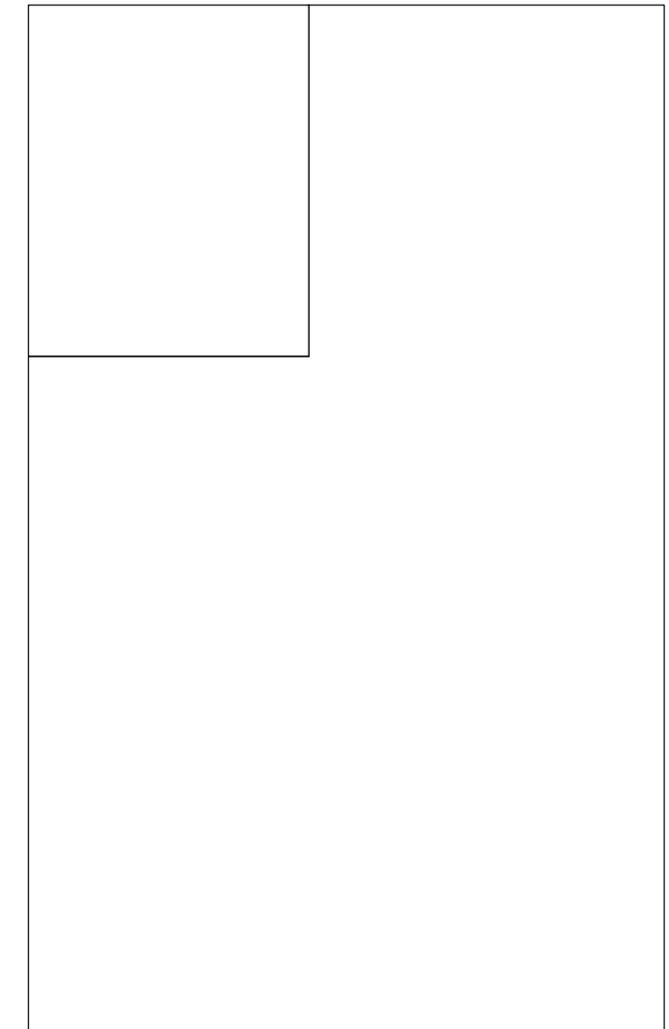
FIGURE 3 - Lead Based Paint Sample Location
 CENTRAL 70 - Structure Survey Assessment Map
 AP-83
 4625 Milwaukee, Denver, CO
 June 29, 2018
 APEC #: 18-3066

- R1 = Room Numbers
- 4 = Lead Base Paint (Detect)
- 4 = Lead Containing Paint (Detect)
- 4 = Lead Base Paint (Non-Detect)

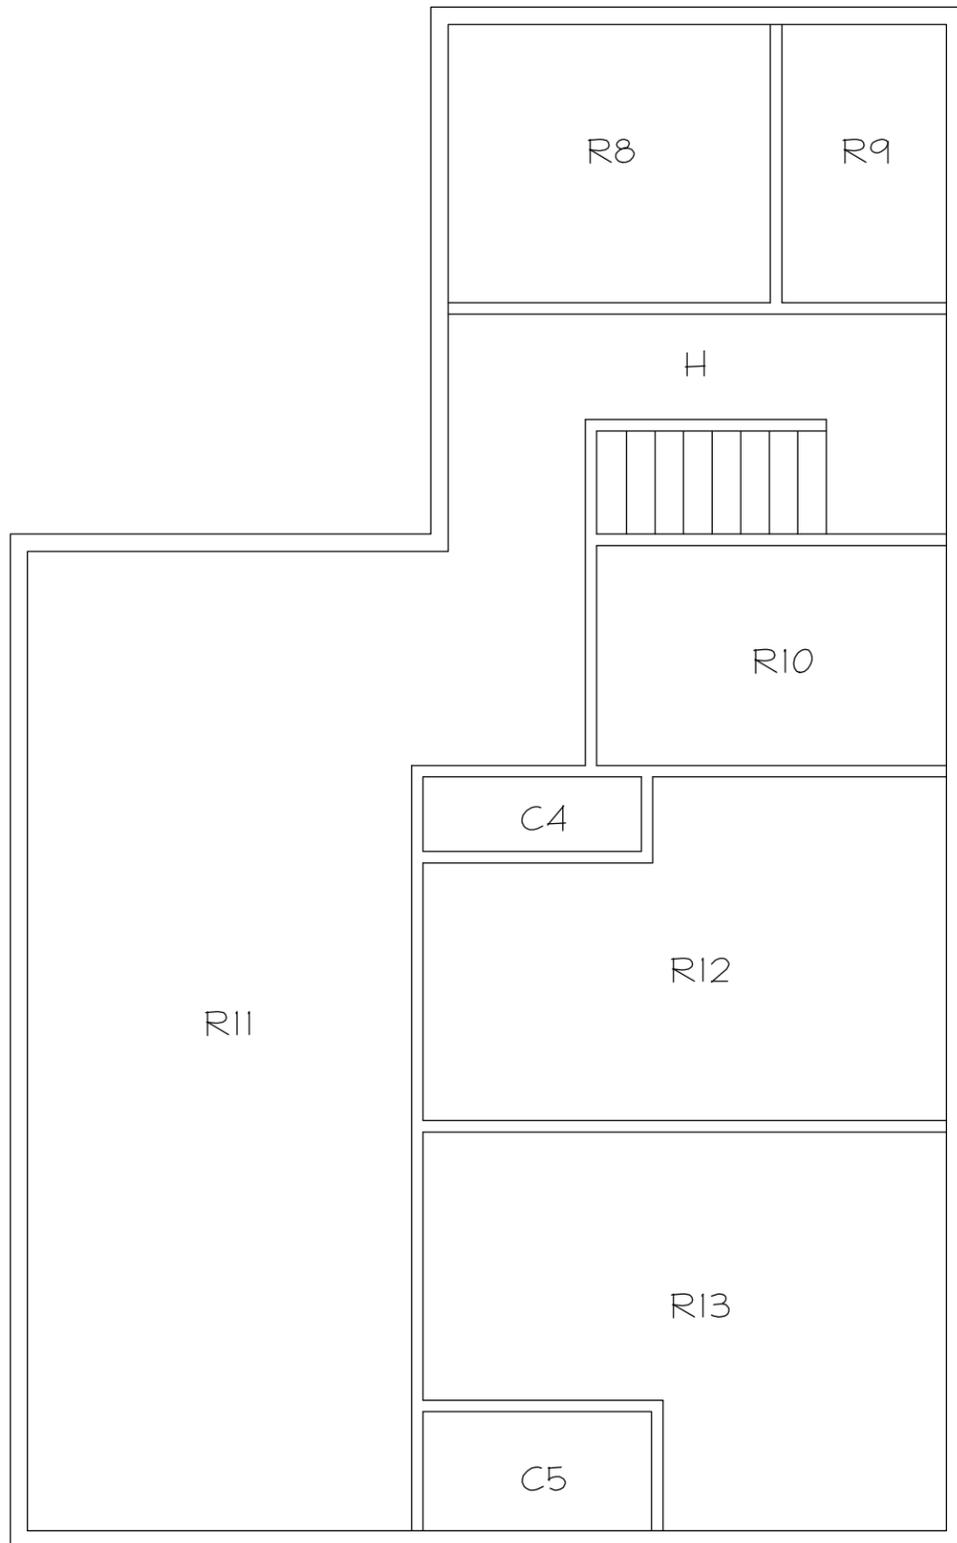
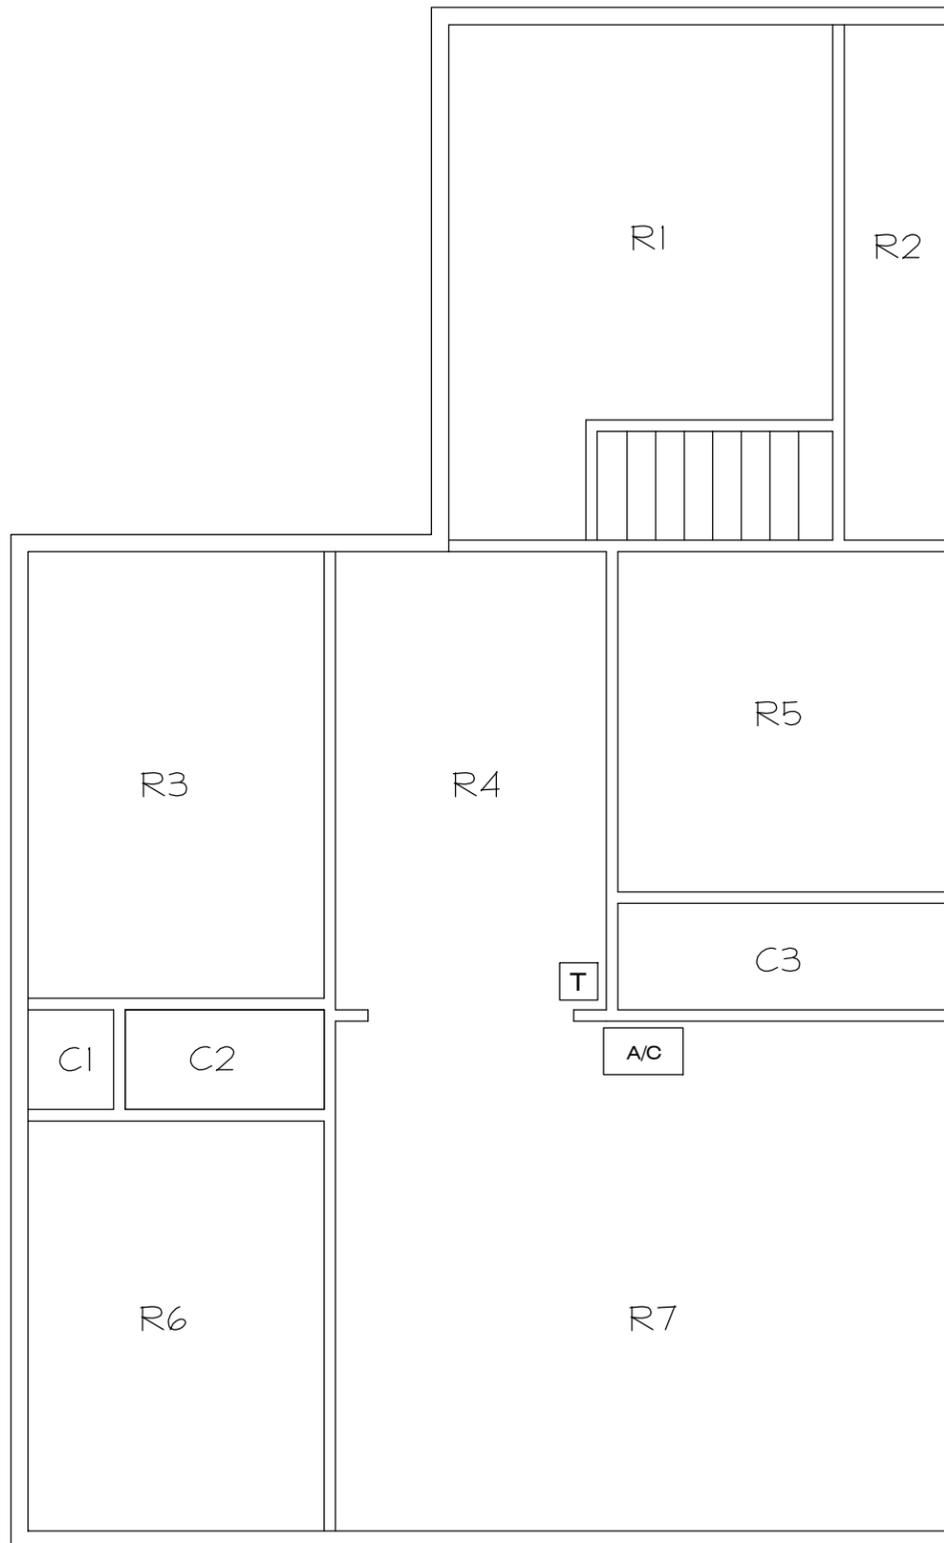
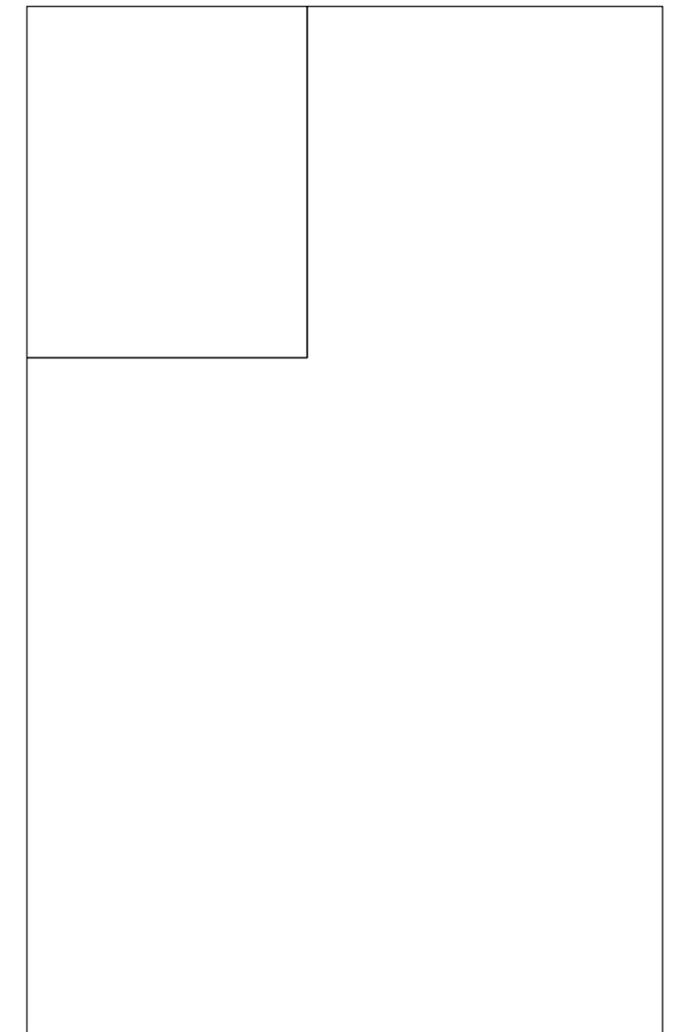
R1 = Room Numbers

A/C = Air Conditioning

T = Thermostat

Several suspect RBMs were visually identified throughout the structure. RBMs that are a cause of concern, when discovered, are discussed below. A complete list of the RBMs is presented in Table 5, and selected locations of the RBMs are depicted in Figure 4.

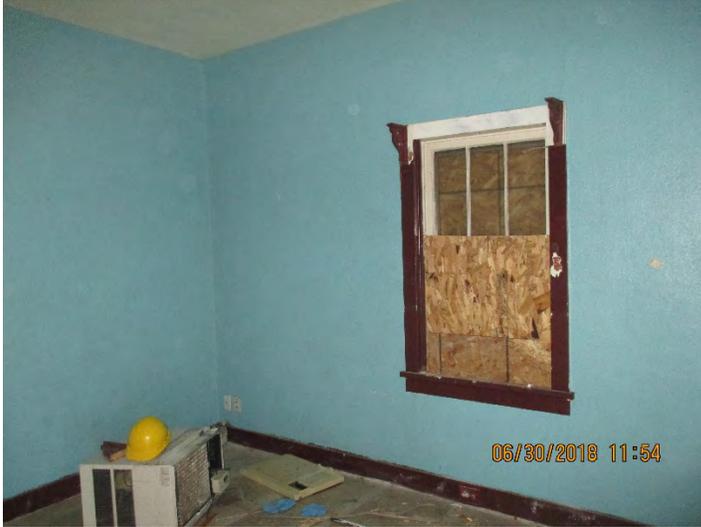
Knockdown Textured Plaster

Samples Represented –
4625M-R7-PL1A
4625M-R7-PL1B
4625M-R7-PL1C
4625M-R4-PL1D
4625M-R4-PL1E

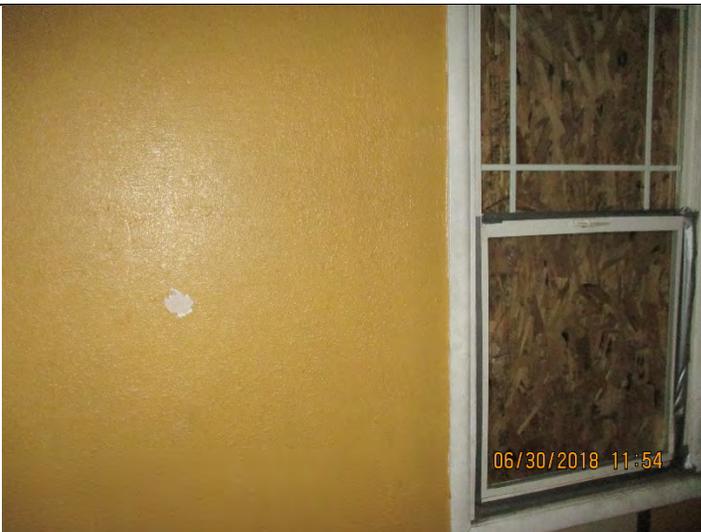
Knockdown Textured Drywall

Samples Represented –
4625M-R6-TD2A
4625M-R6-TD2B
4625M-R6-TD2C

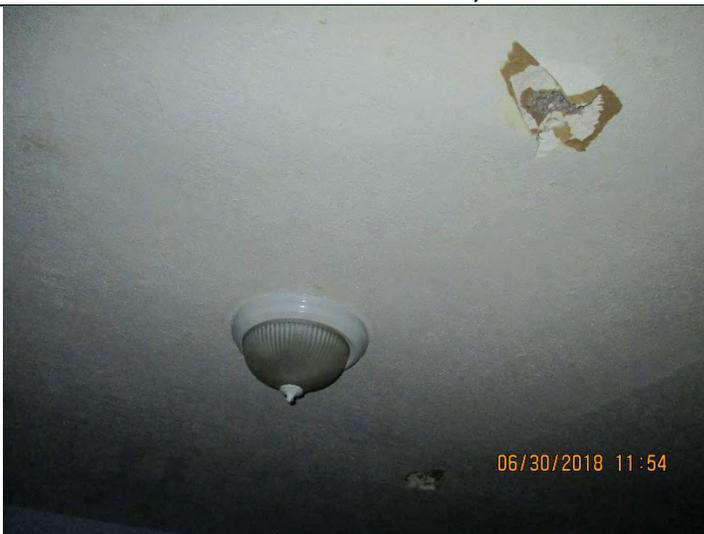
Textured Drywall

Samples Represented –
4625M-R3-TD3A
4625M-R3-TD3B
4625M-R3-TD3C

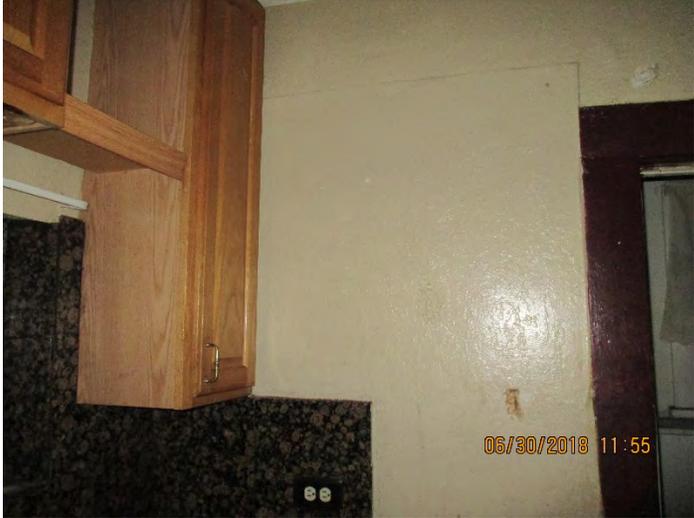
Textured Plaster

Samples Represented –
4625M-R1-PL7A
4625M-R1-PL7B
4625M-R1-PL7C

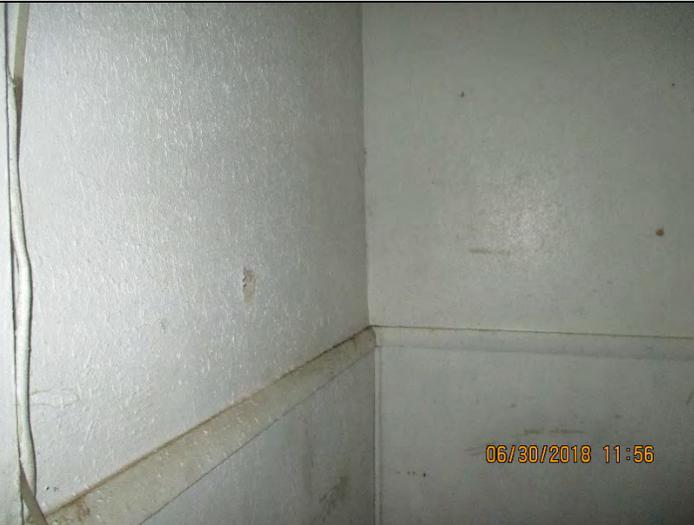
Textured Plaster

Samples Represented –
4625M-R2-PL8A
4625M-R2-PL8B
4625M-R2-PL8C

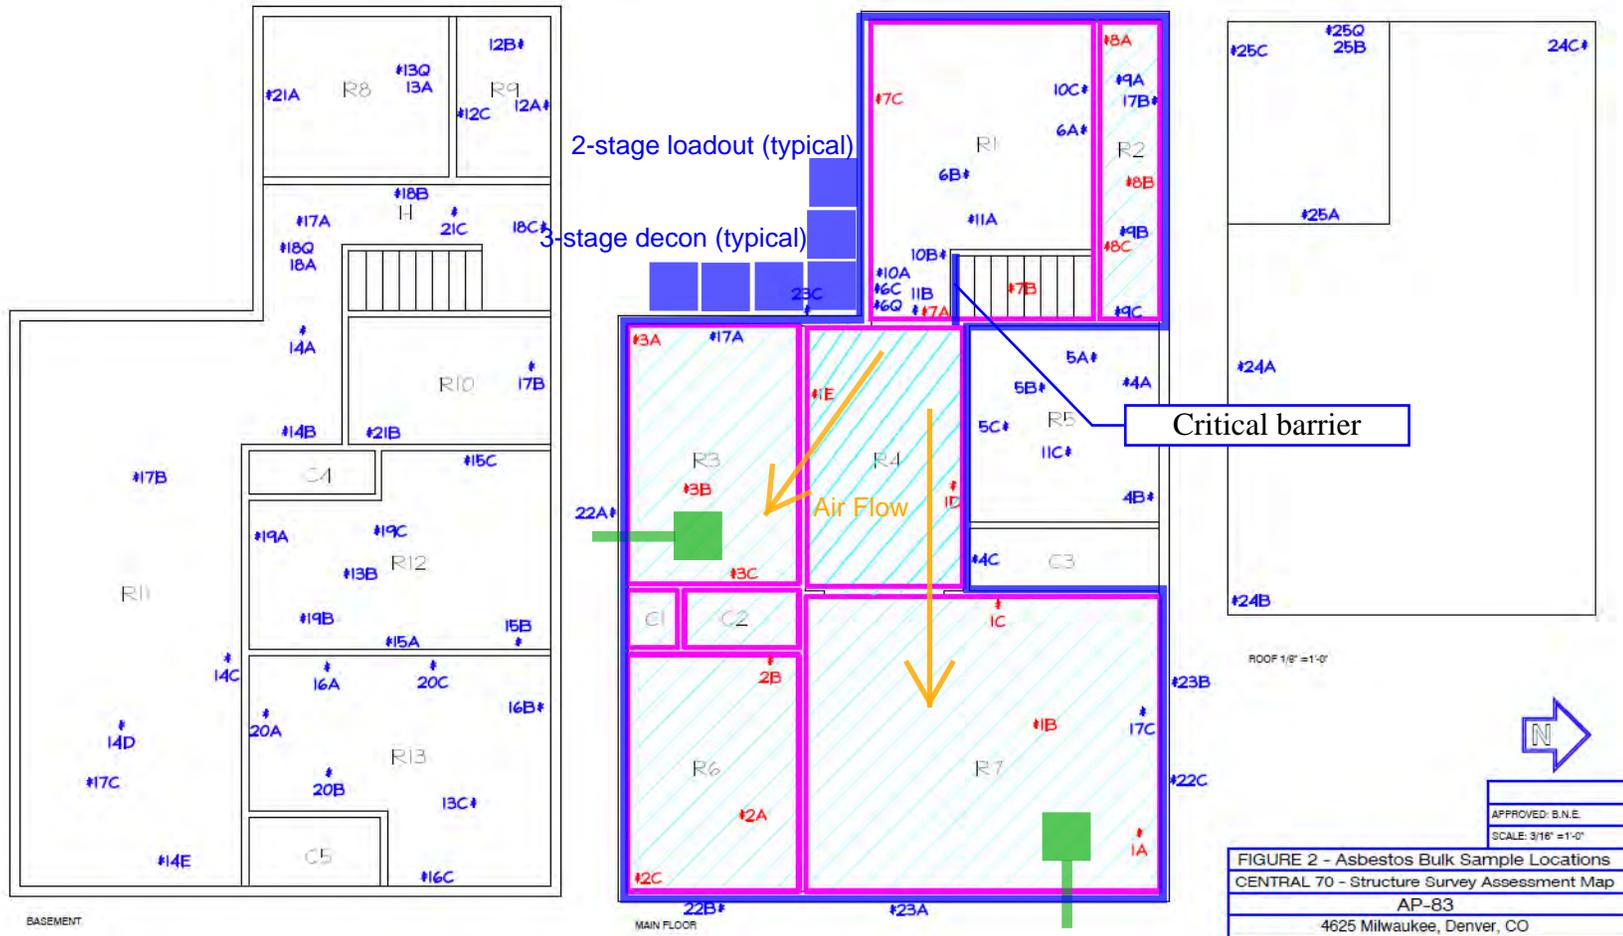
ABATEMENT IN FULL CONTAINMENT

- R1 = Room Numbers
- 4B = Asbestos Samples (Detect)
- 4B = Asbestos Samples (Non-Detect)
- [Pink Box] = Positive Asbestos at Ceiling
- [Pink Line] = Positive Asbestos at Walls
